Guidance to procedures in drydock

Introduction to the steps in underwater hull coating maintenance

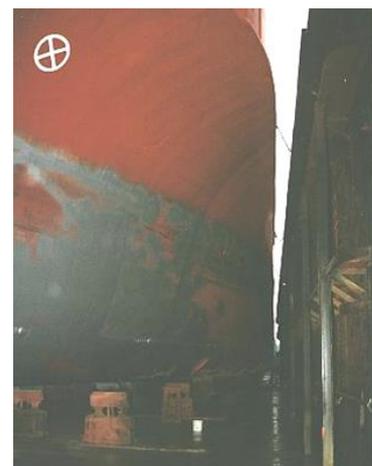
Photo 1: tight space between vessel and dock wall

A situation as shown in Picture 1 on the right should be avoided.

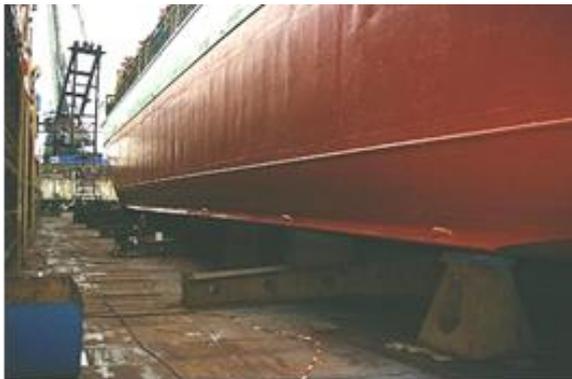
Photo 2: ample space beside vessel

Pictures 2 and 3 below show more favourable situations: both under the vessel and on the side there is space to work.

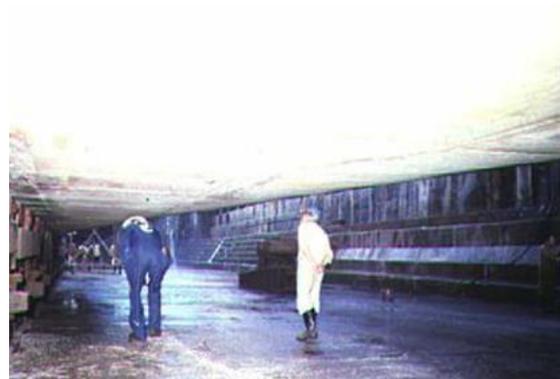
Photo 3: reasonable space below flat bottom

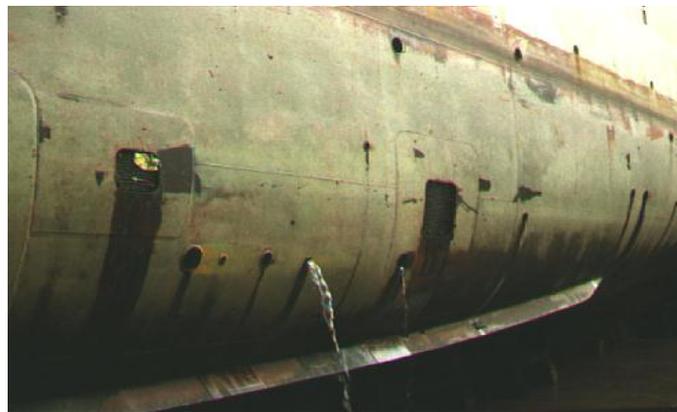
Photo 4: A slime layer on a ship is always present but not always visible

The general term slime is used for bacteria, diatoms and algae spores. Achnantes is a diatom type that can be found in all world seas and on most ships too.

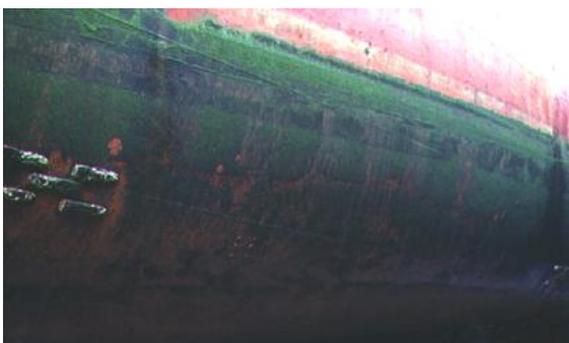
Photo 5: Enteromorpha also known as 'grass'

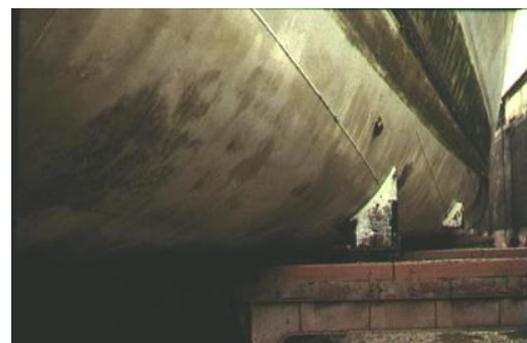
Photo 6: Ectocarpus or 'brown algae'

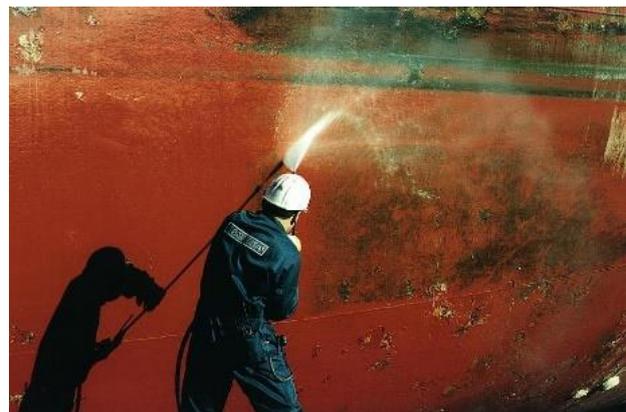
Photo 9: fresh water cleaning

Usually, fresh water cleaning is done immediately after in-docking as any fouling more easily removed when it is has not dried up completely. Hard fouling may require mechanical means to remove.

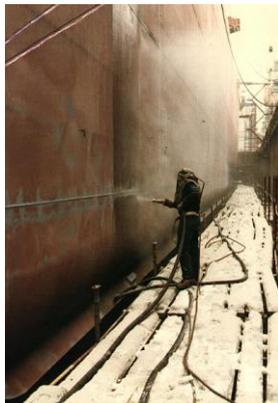
Abrasive blasting is used in most shipyards. High pressure water-jetting is becoming more popular, especially in countries where the disposal of dry dock waste is expensive and/or heavily regulated. Usually blasting to ISO-Sa 2½ is specified for rusted areas (spot) or the entire area to be coated (full).

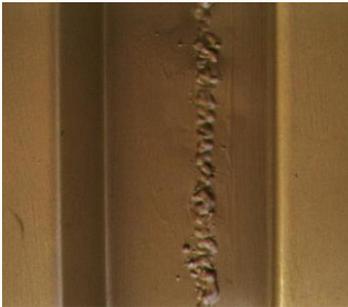
Weld splatter must be removed before coating (left) and weld-seams smoothed (right)

It is important to pay attention to weld seams and edges, as neglecting of these areas will result in preliminary coating breakdown.

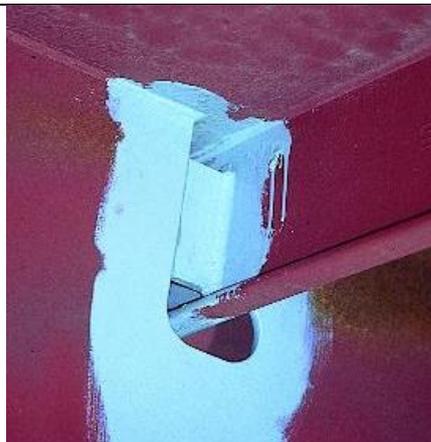
Especially in complex steel structures such as water ballast tanks, stiffeners, weld seams, corners and edges must be stripe coated prior to a full-coat application.

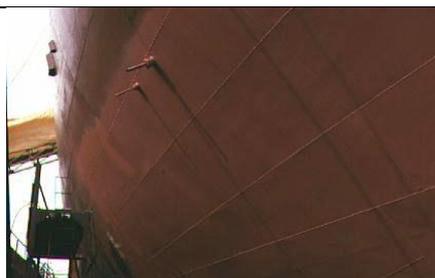
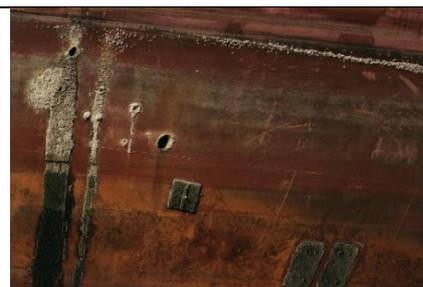
When painting the outside hull, it is important to block hull outlets with so-called scupper plugs (see left picture) or using an extended hose.

Run downs of water etc. can ruin a fresh applied paint layer and lead to premature fouling.

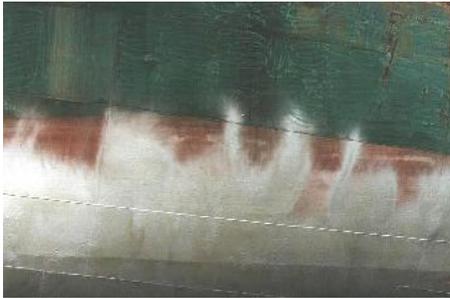
Spraying under windy conditions

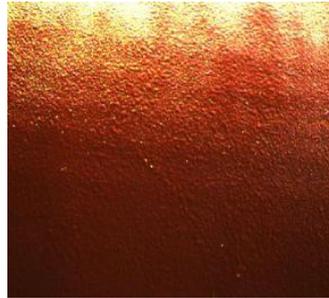
Dry spray

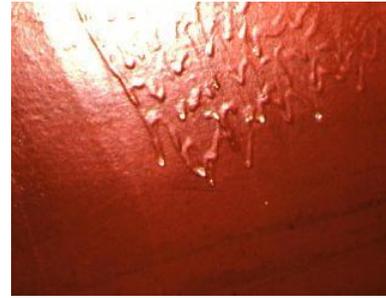
Runs and sags

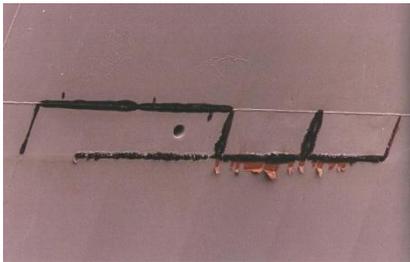
Back-burn caused by welding in the ballast tanks. Proper planning can avoid these situations

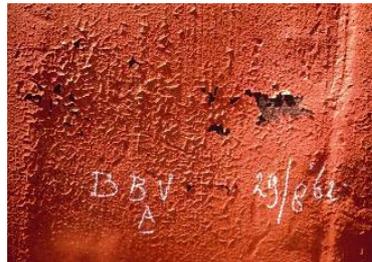
Wrinkling can be caused by the wrong selection of thinner or excessive paint application
